If in Doubt, Don't Just Rip it Out: Assessing Salvageability of Water-affected Building Materials

Authors: Jeremy Stamkos and Tim Law

Date: March 2023

Purpose of document

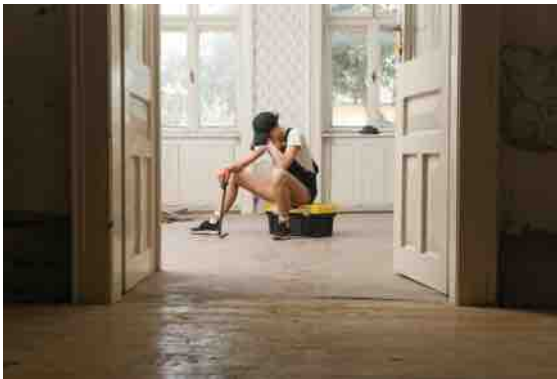
To illustrate, resilient materials such as concrete slabs and timber framing, after exposure to floodwater, present a different risk if left exposed, compared to those intended to be concealed under or behind new floor and wall coverings. The risk of any remaining contamination within or on the concrete slab or timber is mitigated by obstructing the pathway where any remaining contamination can affect the occupant.

The Indoor Environmental Professional (IEP) thus needs to consider which pathways remain accessible between contamination and occupant, and to what extent it can affect the occupant, to decide how much risk is presented by restored building elements.
